## 3D-print materials

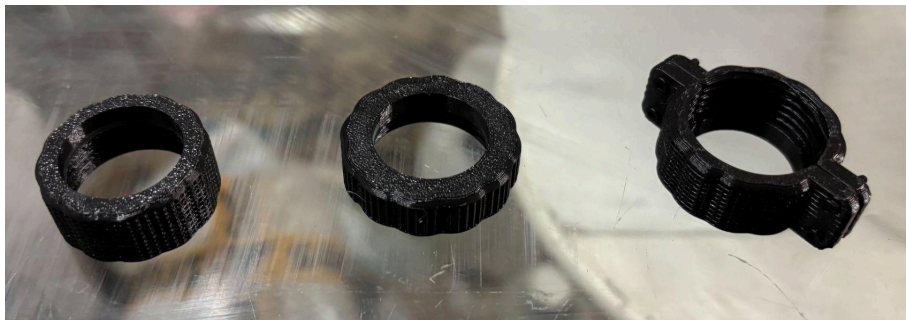
The next challenge was to choose the material for the cap. The most questionable part was whether threads of different materials on the arm connector and cap would intermate. The team prototyped with PETG, as it is cheaper than PA12+CF15, but still strong. In the first iterations, it broke on the layers' connection due to the Z-axis, which was expected. But the team managed to overcome this by creating a two-part cup, thereby reducing friction during tightening. Moreover, thanks to this solution, the attachment can be easily replaced with a new one without having to dismantle the engines or the entire arm mounting mechanism.

Iterations of the cap - from first to the final.
